Structural Steel Coatings for Corrosion Mitigation

Prepared by
Missouri Transportation Institute
and Missouri Department of
Transportation

FINAL Report

October 2010

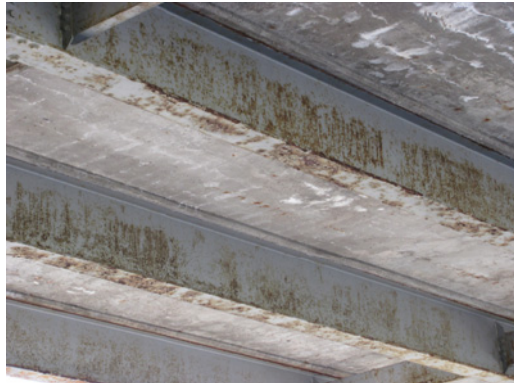
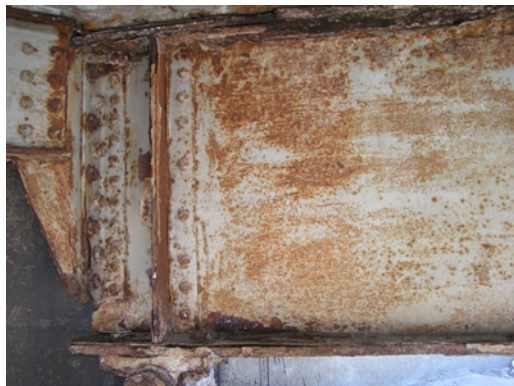
Figure 3.5 Example Photograph for Interior Sections of a Bridge with Coatings in Very Poor Condition.

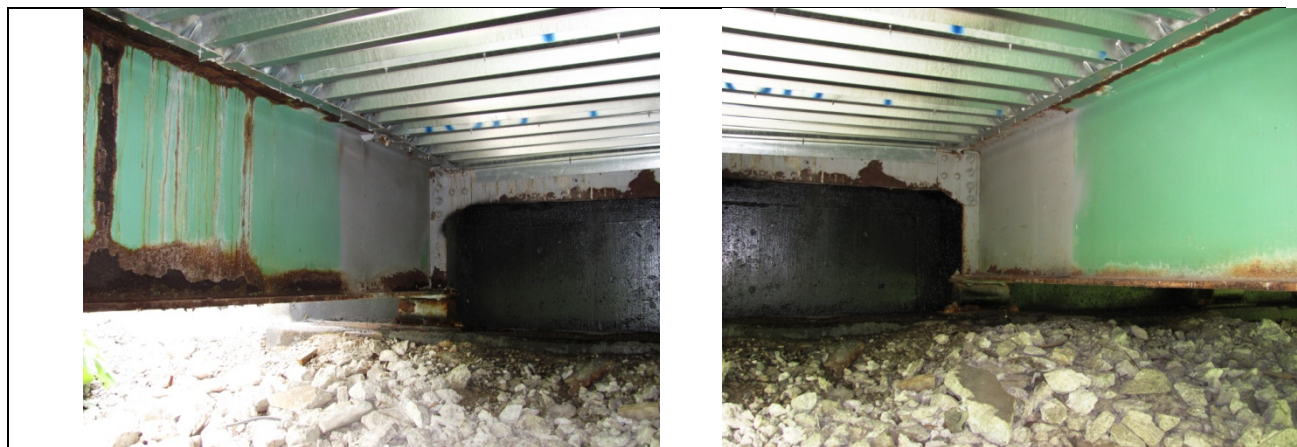
An example of the over-coating with an early failure is shown in Figures 4.2 and 4.3 below. The photos below show zone painting, or limited over-coating by a maintenance crew.

Interior end- span approximately 3 feet overcoated with System S

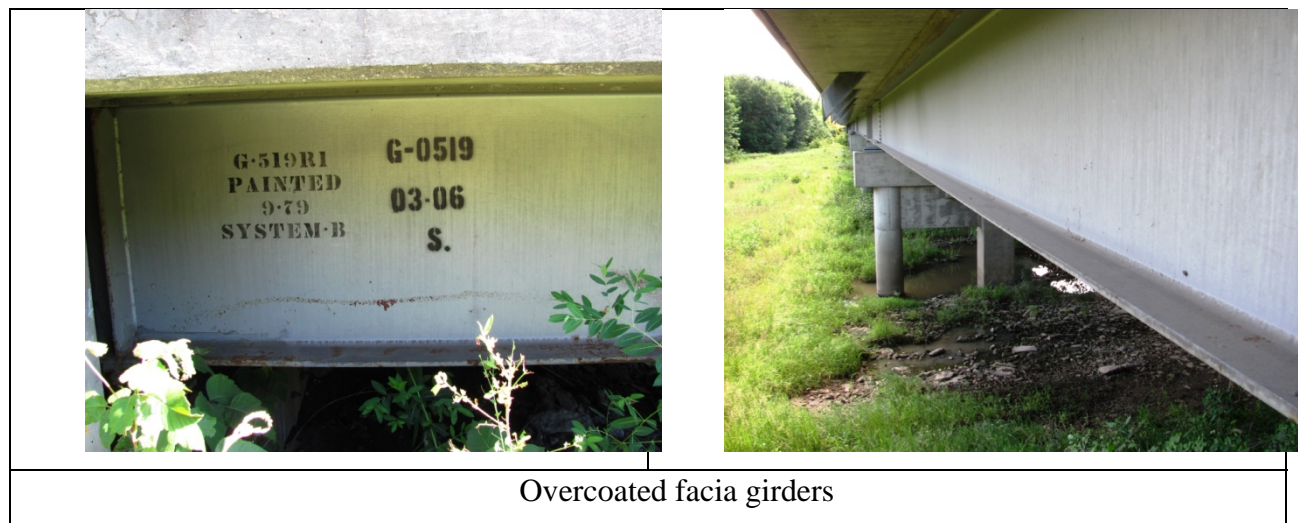
In contrast, Figure 4.4 below shows the fascia girders and beam-end for a bridge overcoated in 2006 with a beam-end rating of fair. Rust amount is less than 1%. This bridge shows good performance of the overcoat with regard to its condition rating. In this case the over-coating is performing well, though there is some rust-back beginning to appear in certain areas near the beam-ends where there is leakage from the expansion joint. In this case, a bridge deck renovation with prestressed panels and extended scuppers is successfully keeping deck drainage from the superstructure.

Figure 4.4 Example of System S Overcoating with Good Performance.

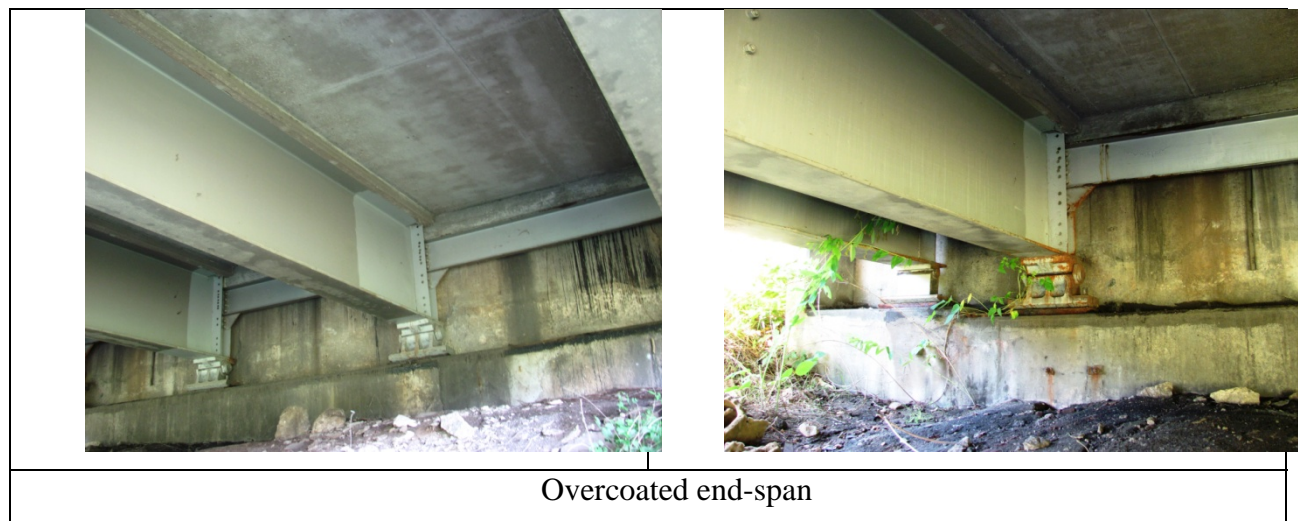
Figure 4.5 Example of Interior Beam-ends with System S Overcoating.

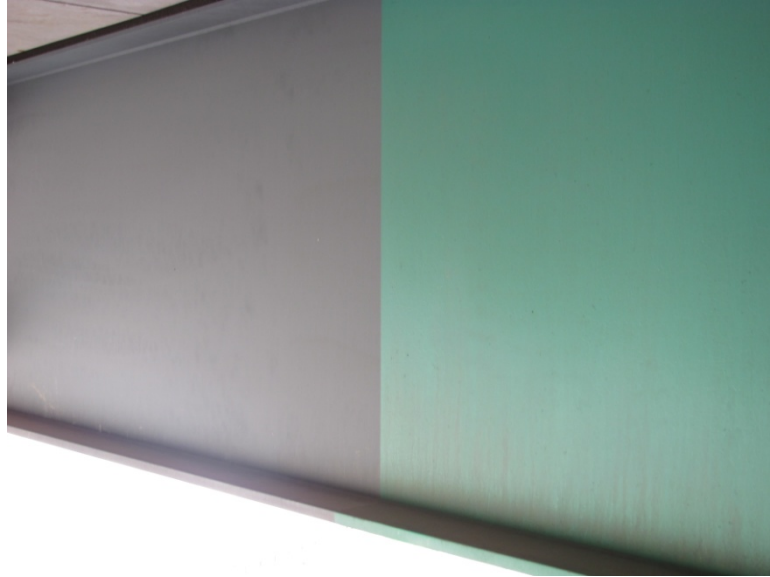
Figure 4.6 Example of 14-year-old System G Coating.
